2008 Annual Inspection Report for the Grand Junction, Colorado, Site

Summary

ANNUAL INSPECTION CONDUCTED
FEBRUARY 28 2008

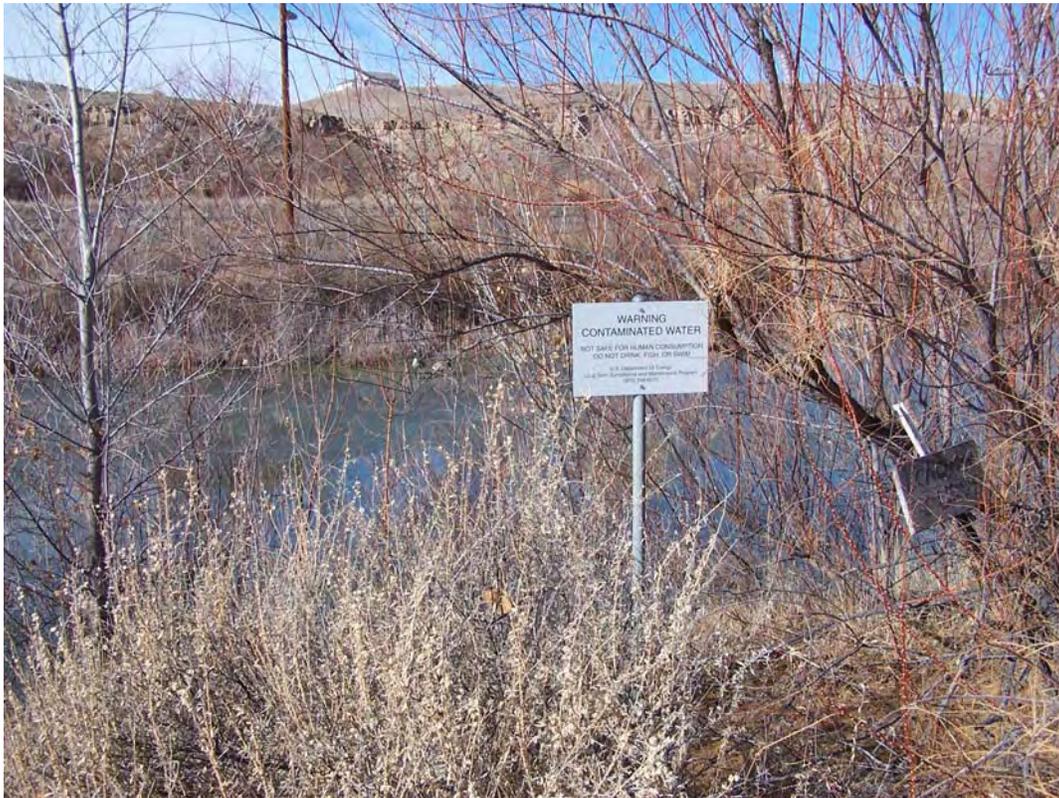
Warning Signs—Thirteen warning signs installed on galvanized steel posts are positioned around the surface water areas so the warning will be visible to a person approaching from any direction of reasonable access (PL-1). Dense vegetation or fences block access to portions of the surface water occurrences. All signs were in excellent condition.

GJO 2/2008. PL-1. South Pond warning sign S5.

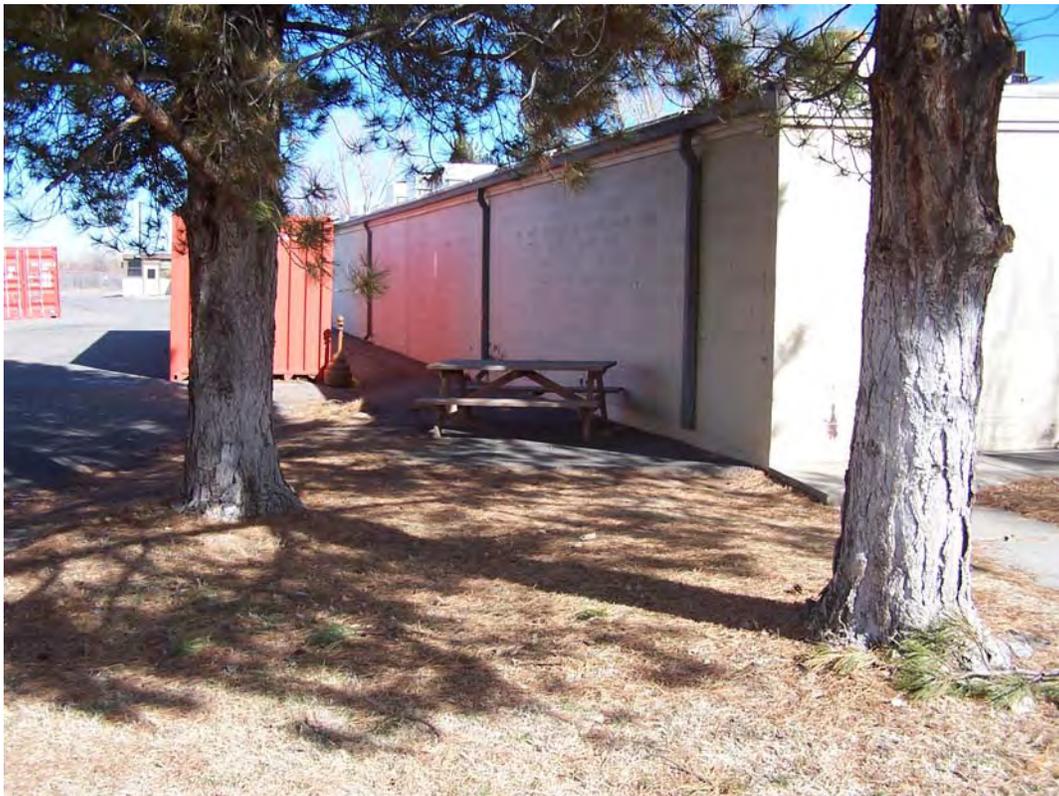
The interior floor area of Building 12A was inspected. There was no visual evidence of floor penetrations in the affected area since the last inspection. Exterior areas adjacent to the contaminated media under the building have not been disturbed (PL-2 and PL-3). The current site owner controls maintenance activities in the exterior areas near the contaminated soil, and DOE contractor personnel observe these exterior areas during normal working activities. Building 20 was demolished, and the underlying contaminated soils were remediated in 2006. The former building location was seeded with grass, and was in good condition.

GJO 2/2008. PL-2. Southwest corner of Building 12A; no evidence of disturbance.

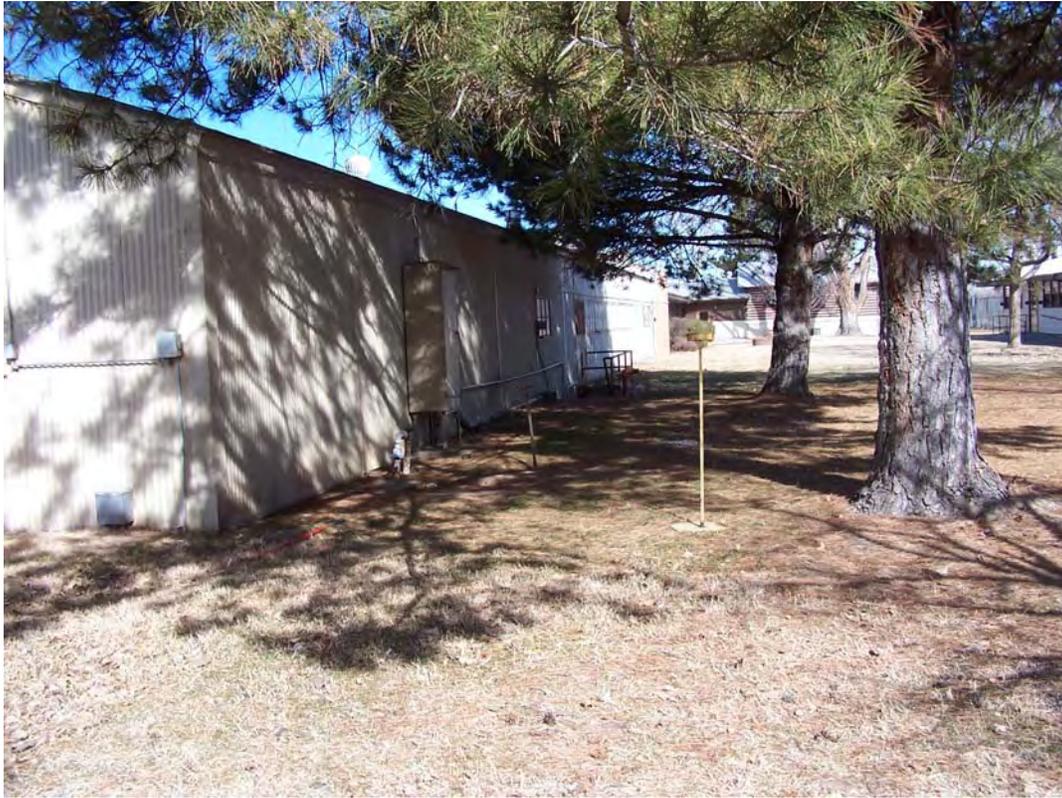
GJO 2/2008. PL-3. Southeast corner of Building 12A; no evidence of disturbance.

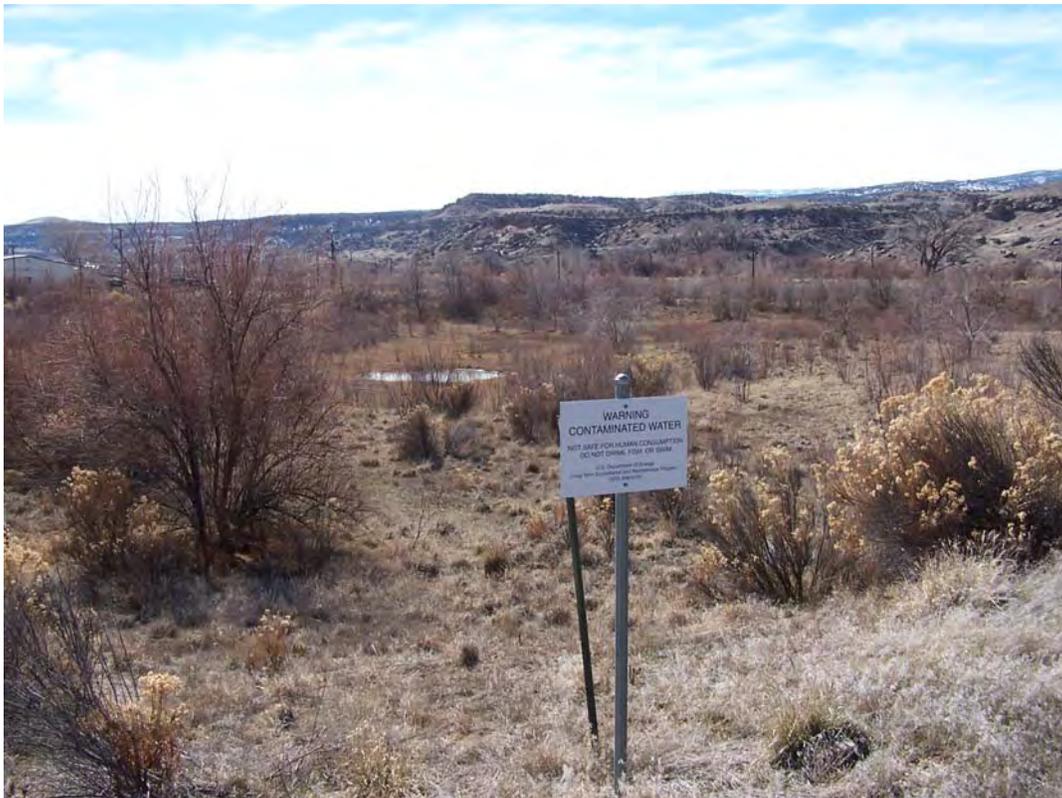
The North Pond, South Pond, and wetland areas (PL-4) are surrounded by a fence, which limits casual intrusion. There was no evidence of fishing, trespass, vandalism, or use of the water.

GJO 2/2008. PL-4. Warning sign S12 near a wetland area at the north end of the site.

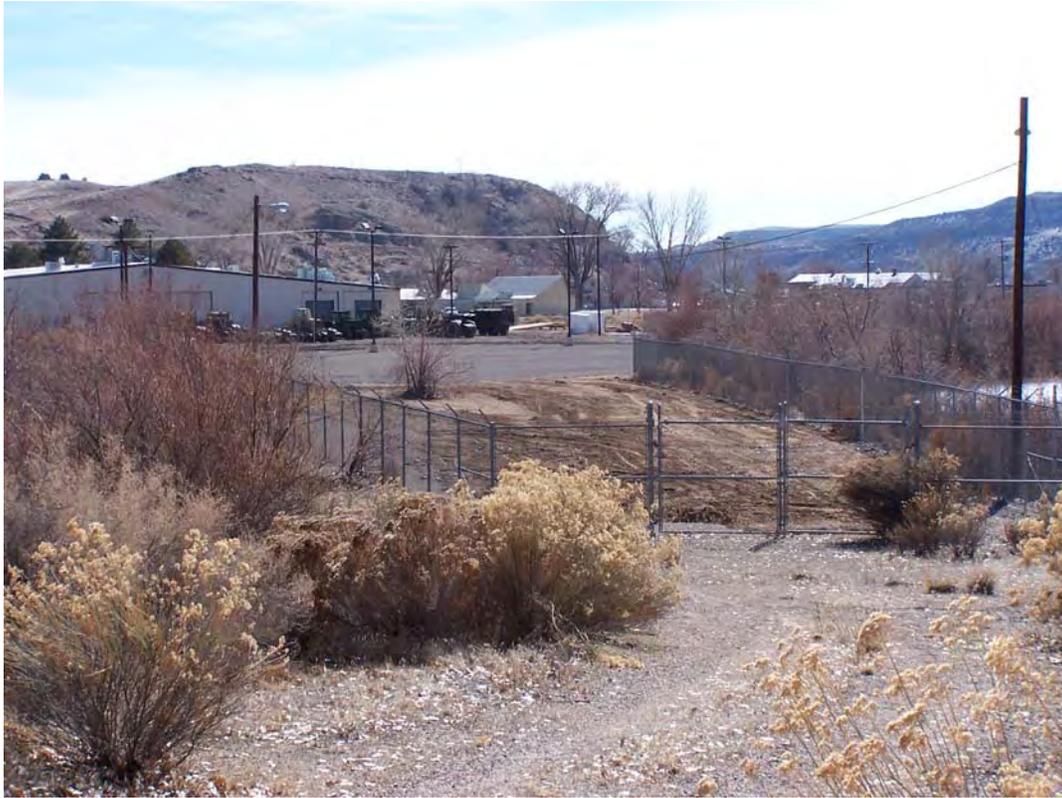
Most of the site surveillance features are in areas not easily accessible by the public due to fencing. The large parking area on U.S. Army property between North Pond and South Pond has been recontoured to facilitate drainage (PL-5) and two new culverts have been installed to drain runoff from the parking area to the adjacent ponds (PL-6). It is unlikely that these activities exposed groundwater. There were no signs of activity, development, or land use change (e.g., well installations or excavations that could expose groundwater) on the site that might degrade protectiveness.

GJO 2/2008. PL-5. Recent grading on the U.S. Army Reserve property.

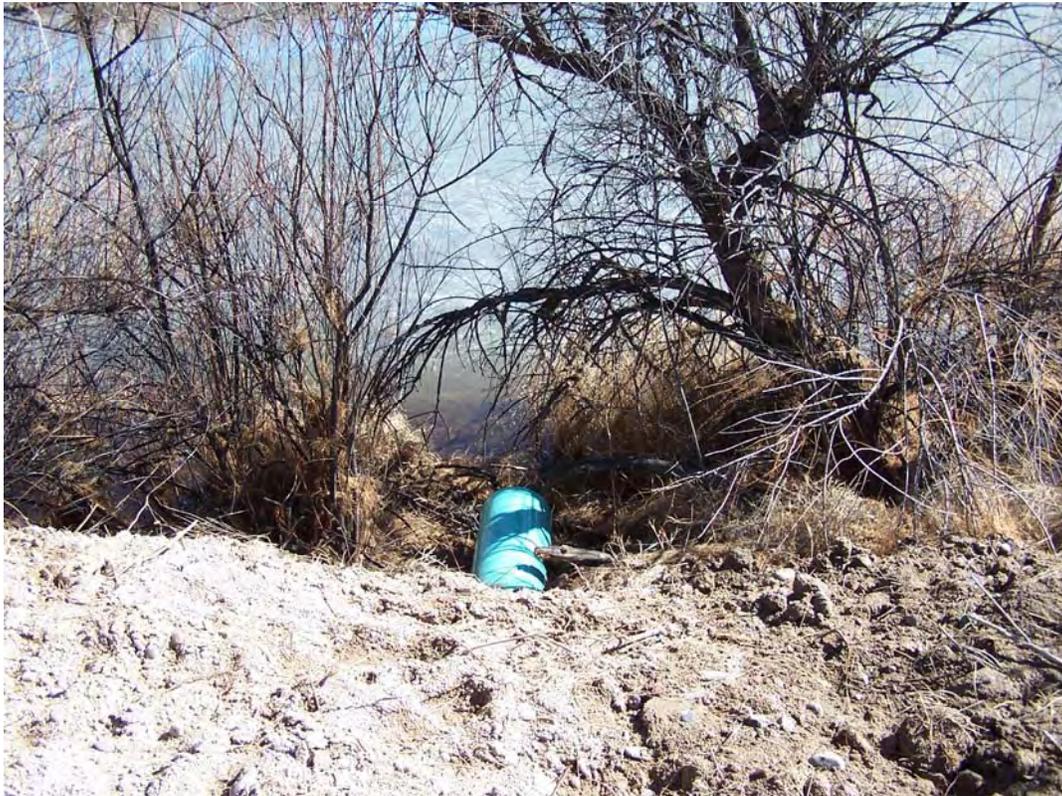
GJO 2/2008. PL-6. Outlet of new culvert at the edge of North Pond.

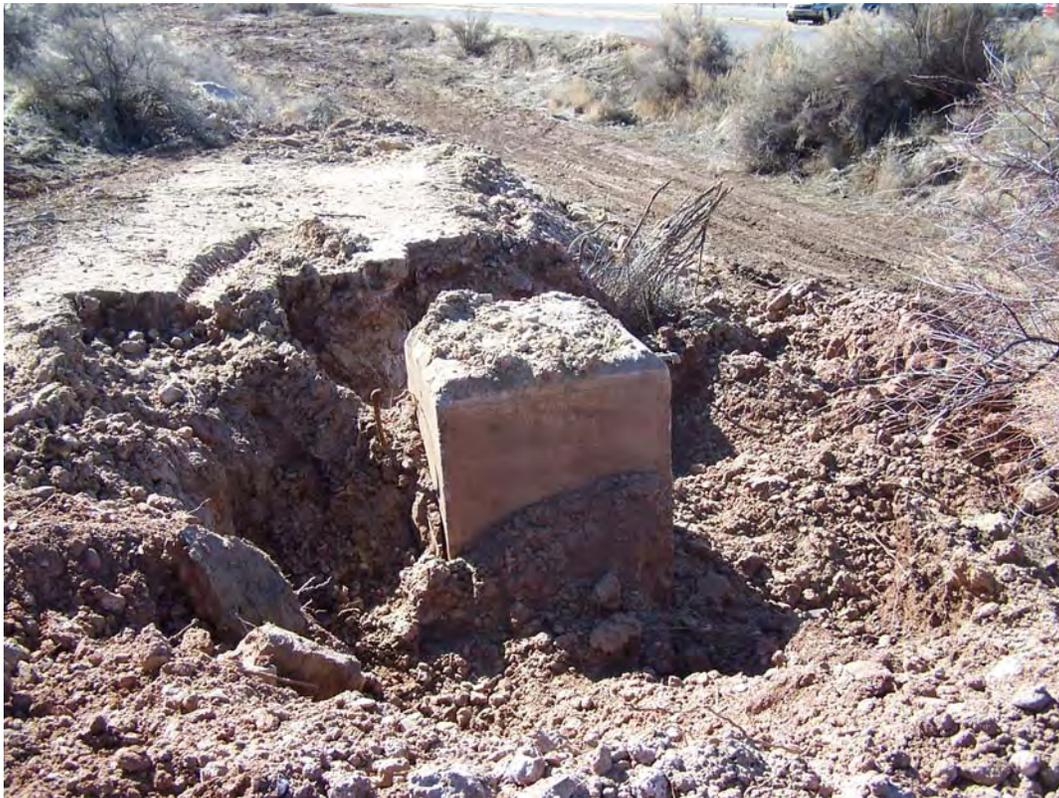
Outlying Area—Private construction consisting of site grading and installation of a trailer house and septic tank are in progress on the adjacent property east of the site (PL-7 and PL-8). The alluvial aquifer apparently is not present under this location. There were no signs of activity, development, or land use change in areas adjacent to the site that might expose contaminated groundwater or impact the natural flushing of the aquifer.

GJO 2/2008. PL-7. Excavated structure on adjacent property east of the site.

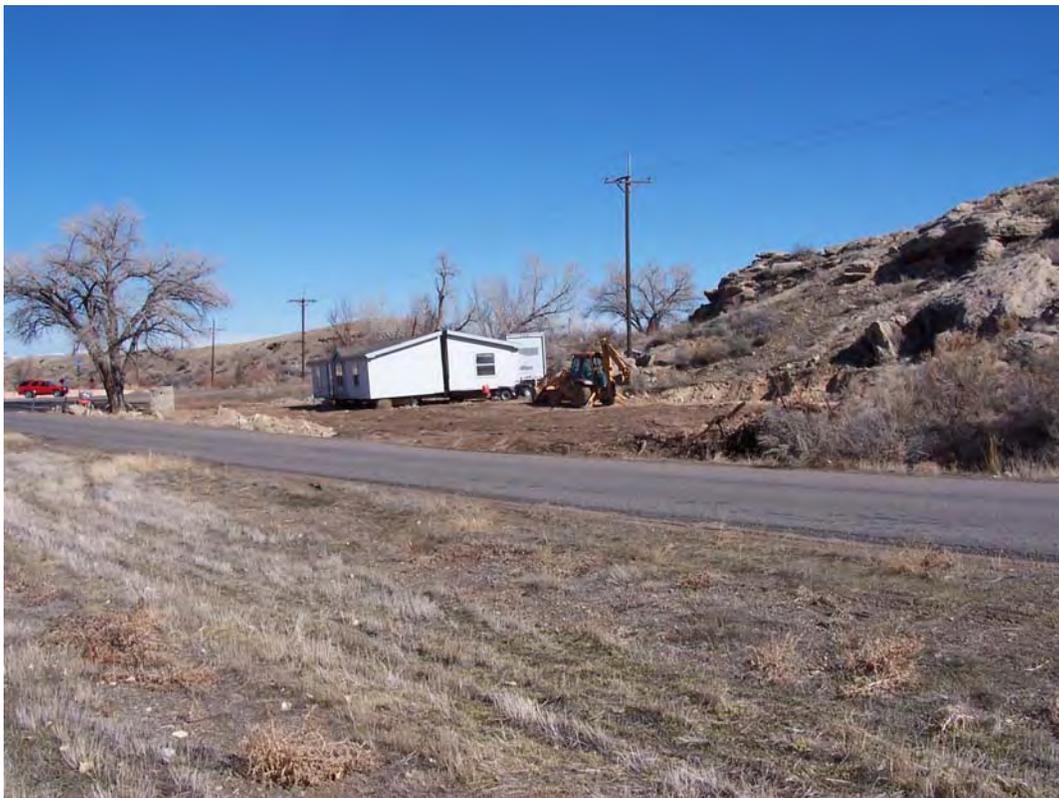
GJO 2/2008. PL-8. Private construction activities on adjacent property east of the site.
